Geosynthetic Installation Quality Challenges from the construction of a Class A facility in South Africa

C. Cilliers

Jones & Wagener, Johannesburg, Gauteng, cilliers@jaws.co.za

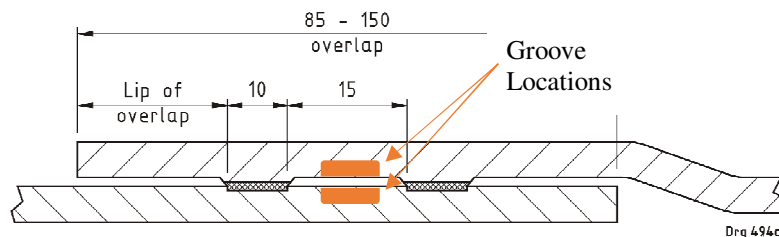
The second challenge concerns the installation of the primary geomembrane as shown in Figure 1. During its installation, specifically during conducting wedge welds (production seams) of panels installed on the side slope, it was noticed that a groove was created within the air channel of the wedge weld as shown schematically in Figure 2. At first it was thought to be only at the start and end of the seam but after taking destructive test samples throughout the length, it was found that the groove was created for the entire seam length (approximately 20m).

Figure 2: Location of grooves in air channel. Figure taken from SANS10409:2005

The engineer was unsure of whether the groove created within the air channel was considered a defect or not. It had clearly reduced the thickness of the base sheet, which raises a concern of future stress cracking. However, the groove is concealed within the air channel and therefore should not be exposed to the environment.

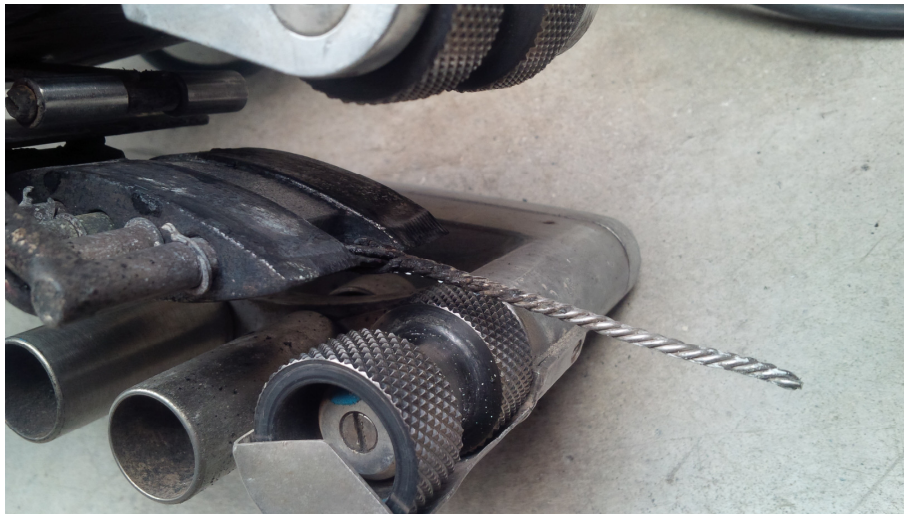
All non-destructive quality control tests carried out on the 27 affected seams had passed including air pressure tests and peel & shear tests on destructive samples. Upon further investigation it was found that the wedge-welding machine had a drag bar fitted that was creating the groove – See Figure 3. The drag bar appeared to be different to typical wedge welding equipment as it was circular and threaded instead of a flat bar. Samples of the welds containing grooves were sent by the liner installer to an independent laboratory and indicative measurements are shown in Table 1.

Figure 3: Groove bar fitted to wedge welder

In agreement with the experts, J&W insisted that the equipment was replaced. By instructing the liner installer to stop welding until he could show evidence that his welding equipment did not create the grooves, it was ensured that no further grooves would occur. The welding equipment was replaced with new equipment within a few days and production continued.

However, there were still 27 panels on the side slopes that contained these grooves and expert opinion was split on removing the seams. It was agreed with the liner installer that the seams would be cut out of the installation and replaced with a patch that would be the length of the panel and approximately 500mm wide. This would result in one wedge weld being replaced by two wedge welds. The employer would initially pay for this work, however, it was agreed that a testing program would follow which would determine if the grooves were a defect or not. The liner installer, confident in his opinion that this was not a defect, agreed to the following test program:

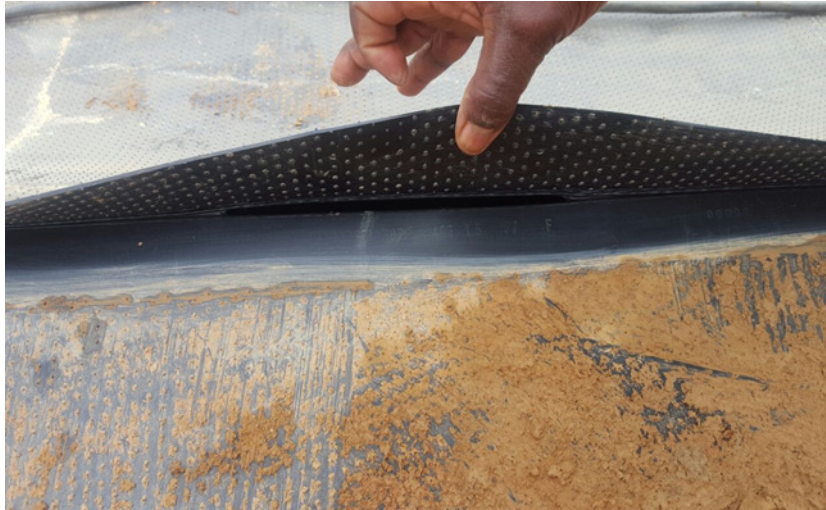
The third challenge, also on the geomembrane installation, was the curious case of damage occurring to the base geomembrane sheet during wedge welding. The damage consists of the bottom liner being slit on the outside of the wedge weld below the overlap – See Figure 4. This is not picked up during air pressure testing.

The suspected causes were likely re-alignment of welding machine, often with jerking motion as it is running, especially on hot days, trimming of the top sheet or sharp material caught on the machine plate of the wedge welder. It was suggested that the best detection measure is vigilant observation of every weld operation and marking any alignment adjustments and using a hand probe / air lance on all flaps or water-puddle / electrical leak location. This is sufficient motivation for constant quality control and assurance during every weld in an installation. It has been reported that failure of welds could be as high as 1% - 1m in every 100m (Erickson R.B. et al, 2008). In the case of this project, the seam was cut out and a new wedge weld was carried out.

Figure 4: Slit created in base geomembrane of a wedge weld.
