# **Lining of a Zinc tailings storage facility and return water dam**

**A. van der Westhuizen**

## **Abstract**

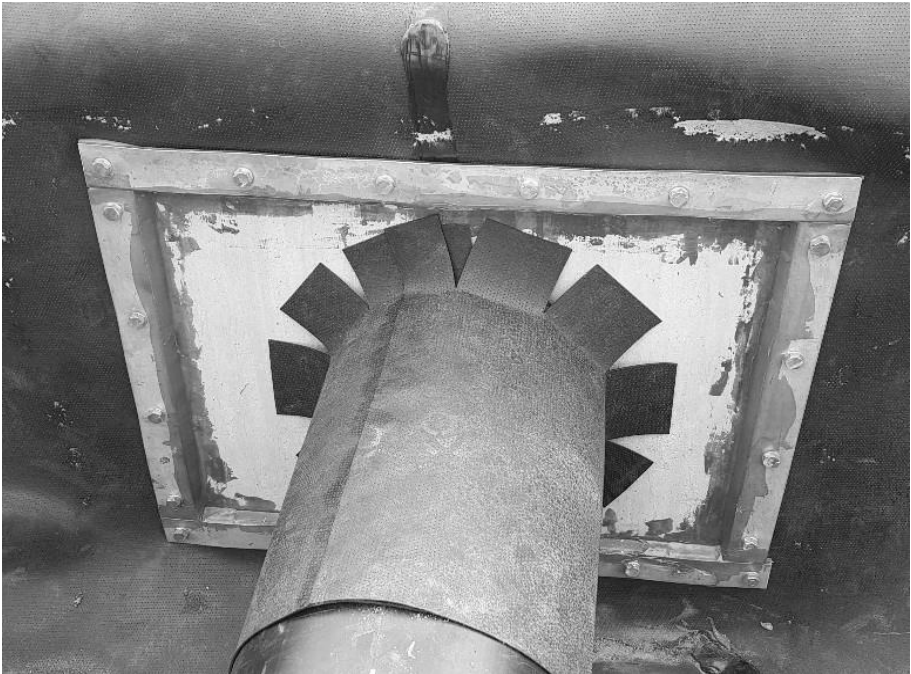
The design of the TSF required a decanting system to enable decanting of supernatant water from the pool that will be generated around the tower. The design also required an intermediate decant at a lower elevation that will be used until the tailings is at a suitable height for the main decant to be functional. The geomembrane surrounding these concrete structures required a secured connection. This was accomplished by using gaskets, flat bars and bolts to sandwich the geomembrane into a “leak proof” system against the concrete. This can be seen in Figure 3 below.

Figure 3. Battening system

The connection of the geomembrane to the concrete structures did not result in any meaningful problems. There was decided to put boots (A patch welded against the primary geomembrane and pipe to cover the gaskets, flat bars and bolts making up the buttoning system. This can be seen in Figure 3 where the piece of geomembrane surrounding the pipe is still required to be connected to another piece of geomembrane to cover the entire concrete face) as a secondary barrier on the anchor blocks constructed in the toe of the starter wall and toe wall.

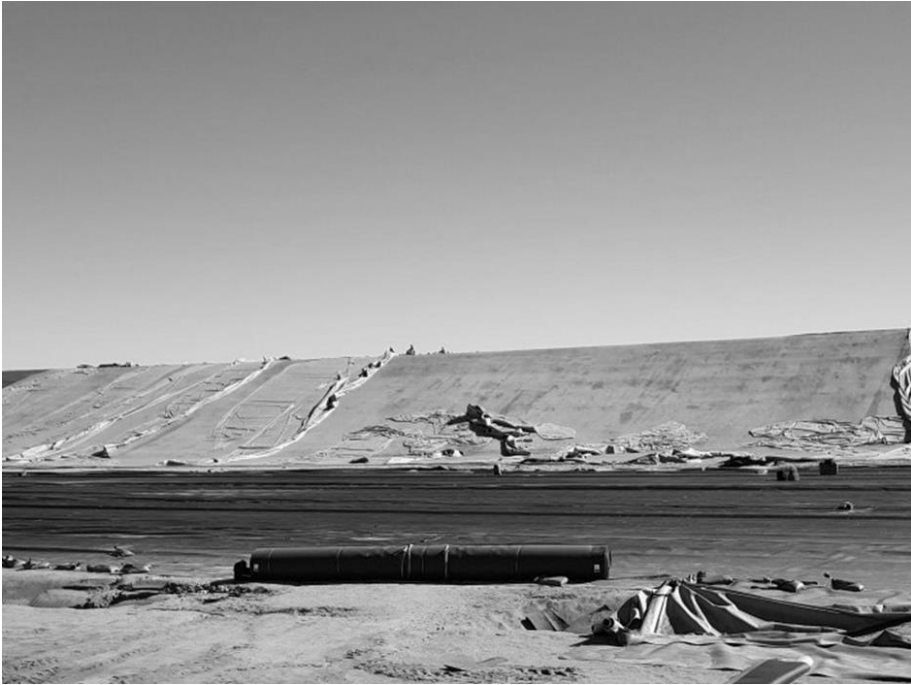
- There were some instances where the crest of the starter wall's geomembrane was lifted due to wind uplift. Many square meters of geotextile moved from its original position underneath the double textured geomembrane. This was mended by cutting open the geomembrane, re-placing the geotextile, tack welding the outer edges of the adjacent geotextile panels together and then welding the geomembrane panels. Sand bags were placed in the anchor trench at the top of the starter wall to combat the wind uplift further. The problem and solution can be seen in Figure 8 and 9;

Figure 8. Newly opened (cut) starter wall

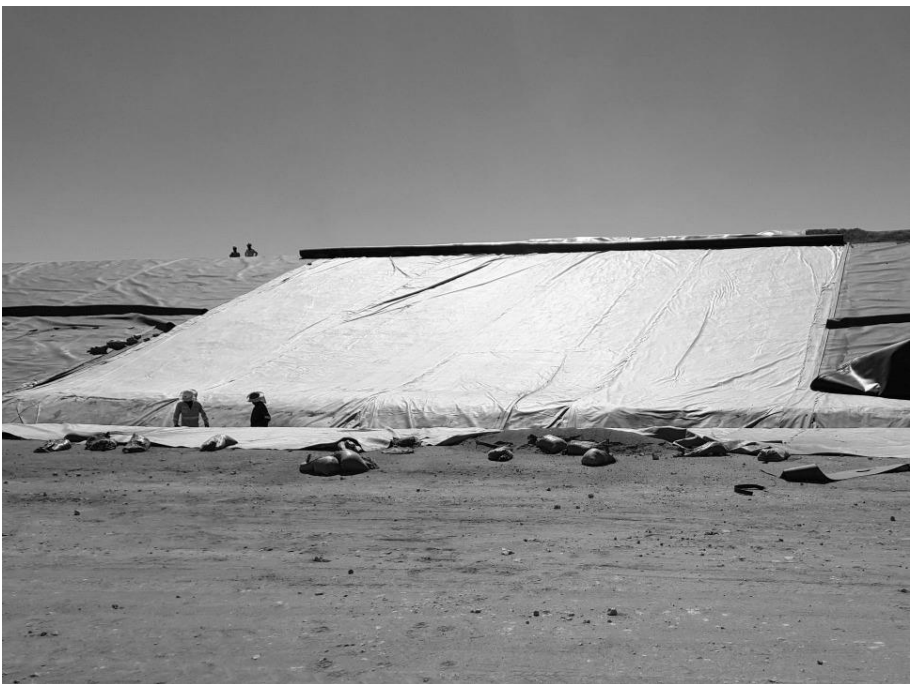
Figure 9. Re-placed geotextile with tacked edges

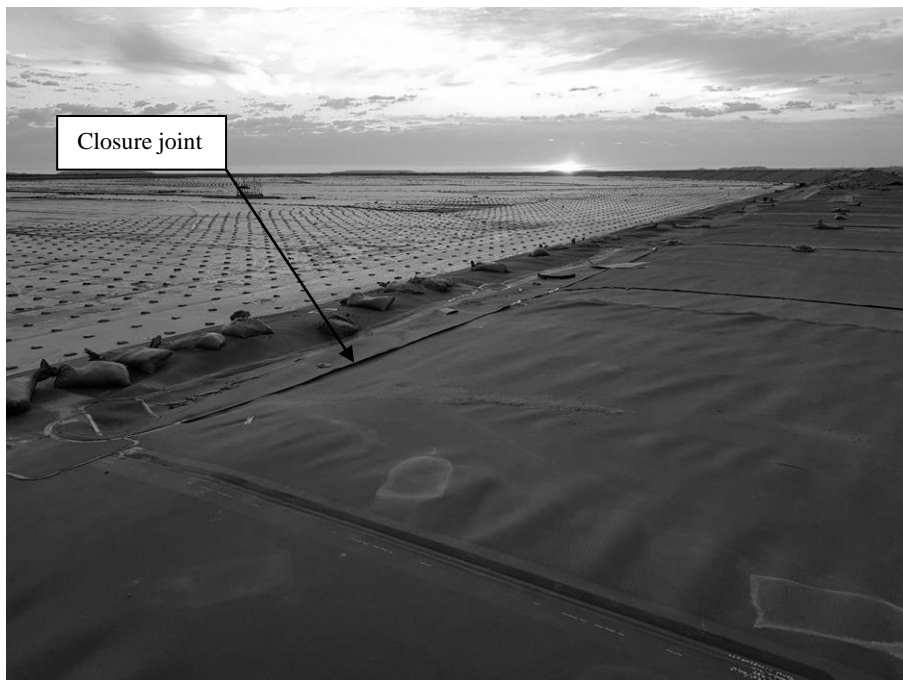
- The expansion and contraction problems were mended by placing the sandbags or the road on top of the starter wall before any closure weld could be done. If this was not possible (wind ingress) and the closure weld had to be done, the drains adjacent to the starter wall were recommended to be filled when it was a colder part of the day (morning). An example of this can be seen in Figure 10;

Figure 10. Crest on the starter wall being ballasted with sand bags

- In both areas, a certain assigned work force walked the surface after and during prep work to pick up rocks that did not meet the specification; and
- During the lining process, many of the geomembranes leading edges were not connected to another fixed (drain) piece of geomembrane. This resulted in wind ingress and uplift over the geomembrane which caused excessive wrinkles in localized areas. These wrinkles were cut and pulled out. Sand bags were placed in a pattern to combat this from happening further as can be seen in Figure 10 above.
