# **Geotextile Sand Containers- Erosion Protection in Marine Applications**

**Chanel Addel Pillay, Yugeshee Naidoo**

This paper explores the use of geotextile sand containers (GSCs) as an erosion protection and rehabilitation measure along the coastline of South Africa. GSCs can be manufactured from a multi-layered geosynthetic material, comprising of a nonwoven, needle punched, staple fibre and continuous filament geotextiles with a high strength composite fabric. The GSCs are considered to be a soft solution utilizing in-situ material and eliminating the need for imported material thereby reducing beach contamination. Over the last decade, these GSCs have been installed on different beaches along the KwaZulu-Natal Shoreline from Durban to Richards Bay. In this paper, we look at the performance of these GSCs and assess its durability, through case histories, especially after the recent high spring tides experienced.

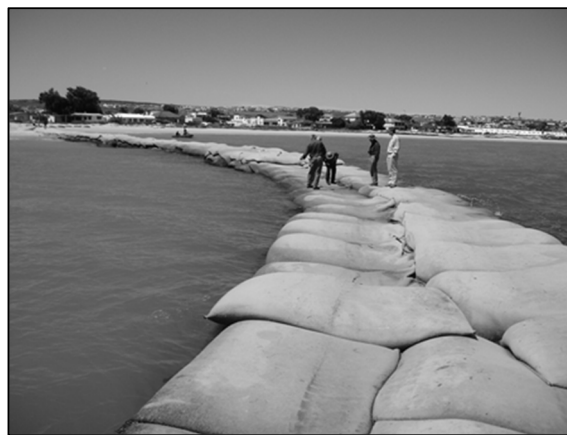
Figure 3: the GSC groyne extending out

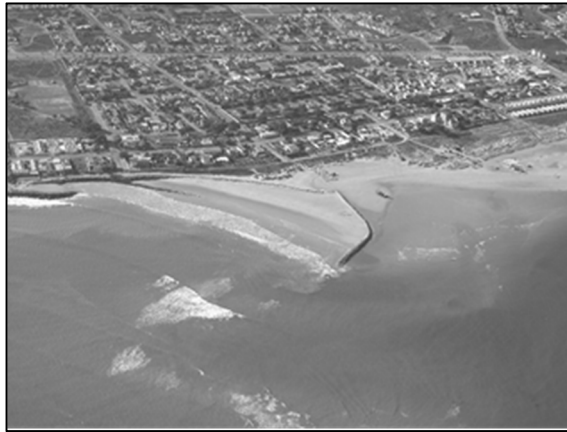
Figure 4: 10 months after the construction of the groyne

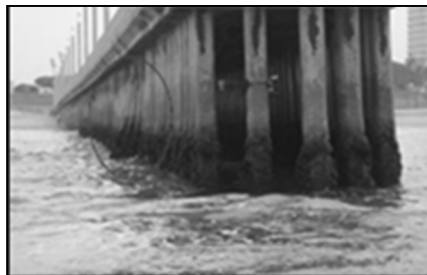
Figure 6: Failure of the piles (CSCM)

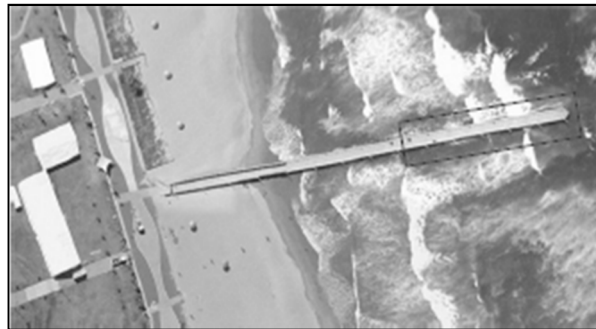
Figure 8: 80m of the seaward deck was removed and replaced by a wider concrete deck (CSCM)

To alleviate the issue discussed in the first problem the municipality designed a wider concrete deck with deeper piles replacing the old structure thus stabilizing the pier (figure 8). The GSC's were installed within the pier to reinstate the rock groyne to the original design level thus correcting the behavior of the rip current. This was quite an intricate installation. The GSC's were hydraulically filled as discussed under 'method of installation'. Tidal behavior determined when installation would occur, at low tide the GSC was lowered into the water where a diver would then direct the GSC into position before releasing it.

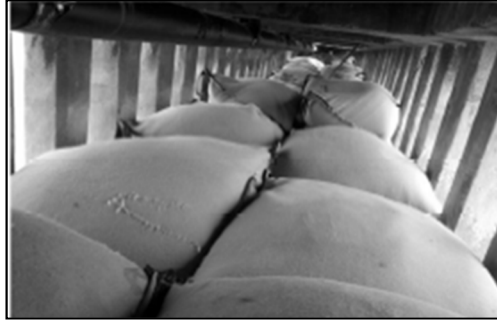
Figure 9: GSC's used to restore the design rip current. (CSCM)

The engineering approach to reduce and limit further scouring at the seaward face of the pier involved the installation of GSC's. The GSC's were stitched together in a 'mat formation' with 3 bags laid adjacent to one another and placed in front of and along the sides of the newly constructed piles on the sea bed. The purpose of the bags was to provide protection during large storms and alleviated the force of the wave action against the pier, thereby reducing the original 8m scour depth.

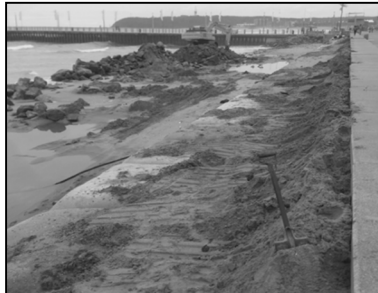
Figure 10: GSC's during installation

As predicted the erosion protection measure was tested shortly after being installed as the Durban Central Beach Front was subjected to spring tides coupled with a storm surge, which resulted in very high sea swells and harsh wave action crashing against the promenade (figure 13). The section in which the GSCs were installed experienced the least amount of damage. The geobags protected the Promenade and also acted as an energy dissipation breaker to the heavy wave action. This incident clearly highlighted the importance of the properties discussed that enable the GSC to perform well under severe storm conditions. In retrospect the measures that had been used previously, in the form of rip-rap, did not perform as well as the GSCs. The old rip-rap is evident in Figure 10.

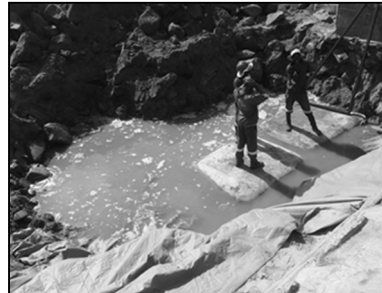
Figure 11: Initial installation of GSC's

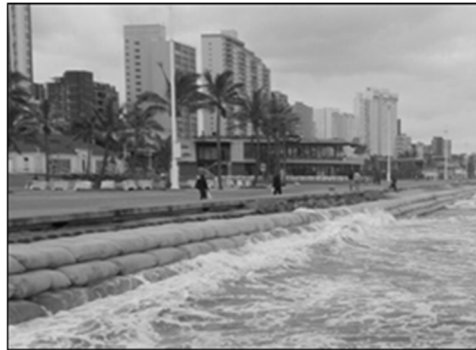
Figure 13: High Sea swells up against the recently installed GSCs
