Geosynthetic Installation Quality Challenges from the construction of a Class A facility in South Africa

C. Cilliers

Jones & Wagener, Johannesburg, Gauteng, cilliers@jaws.co.za

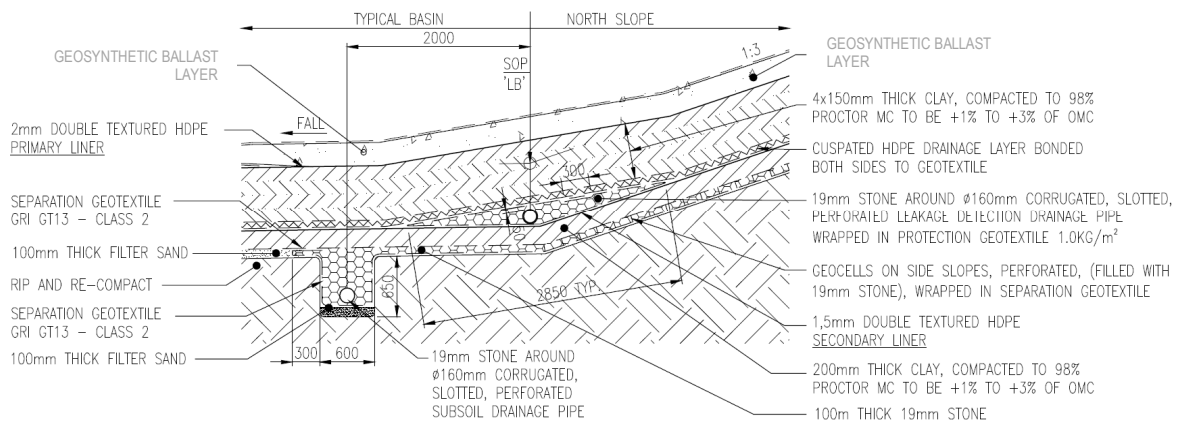
Figure 1: The Class A liner detail

The liner system constructed in this case study is shown in Figure 1. As required by the South African Class A Liner Standard in the national norms and standards (GN 636), it is a double composite liner separated by a drainage layer with a subsoil drainage layer below the liner and a ballast layer above. In this application the drainage layer and the ballast layer are replaced by geosynthetic alternatives.

As shown in Figure 1, the leakage detection layer was formed by a drainage composite formed by an HDPE cusped sheet bonded on both sides to a non-woven geotextile. During construction, the installation of the drainage composite was carried out in conjunction with the secondary geomembrane, which was placed on a compacted clay layer. The primary clay layers were to follow after the drainage composite.
